Amgen Parking Garage

Seattle, WA

Hycrete Saves Skanska 30% on Waterproofing and Amgen \$1.4M Over 30-Year Building Life

Structure:	Parking Garage
Application:	Post-tensioned deck and elevator pit
Owner:	Amgen
General Contractor:	Skanska USA Building, Inc.
Architect:	LMN Architects
Engineer:	Coughlin Porter Lundeen
Concrete Contractor:	McClone Construction
Ready Mix Provider	Cadman

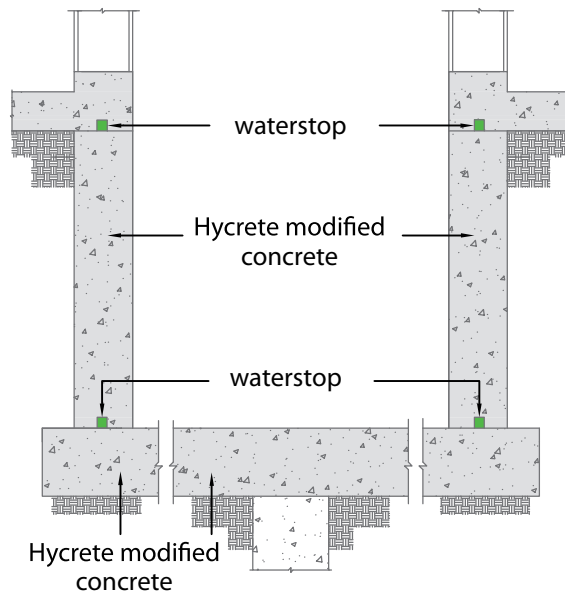
Simple Detailing for Elevator Pits

I loved Hycrete concrete. The waterproof concrete was very user friendly and had no odors. We even saved a step at the elevator pit walls by eliminating the need for a membrane. This saved us a lot of time. Cadman and the Hycrete team provided great onsite assistance. I will be looking for future opportunities to use Hycrete waterproof concrete.
